Investigation Report

Department of Health

Clean Water Branch

Facility: Waste Management Hawaii/CCH

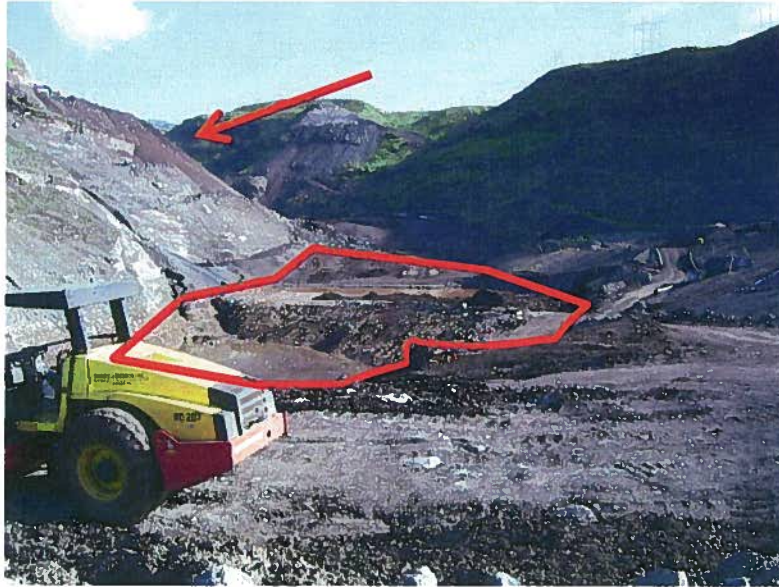
Photograph # 1

Description: View of the E6 cell (Red Outline) facing north. The headwall is located towards the end of the valley (Red Arrow). The headwall was under construction at the time of the tour.

1) Prior to conducting the tour of the Landfill, J. Whelan conducted a briefing regarding the status of the Landfill. J. Whelan stated that the Landfill was being expanded. J. Whelan stated that as part of the Landfill expansion, Waste Management Hawaii was in the process of building a headwall and storm water diversion system (Photograph 2) located above the E6 cell. J. Whelan stated that the headwall was approximately three (3) weeks from completion when the December 19, 2010 rain event occurred. J. Whelan stated that the Landfill had experienced heavy rainfall on the morning of December 19, 2010 which resulted in the Landfill's E6 cell (Photograph 1) being flooded by storm water run-on. J. Whelan stated that the storm water run-on filled the E6 cell and an area immediately south of the E6 cell. J. Whelan stated that had the headwall been completed, storm water would have been diverted around the E6 cell (Photograph 2) to the Landfill's detention basin located on the south side of the Landfill.

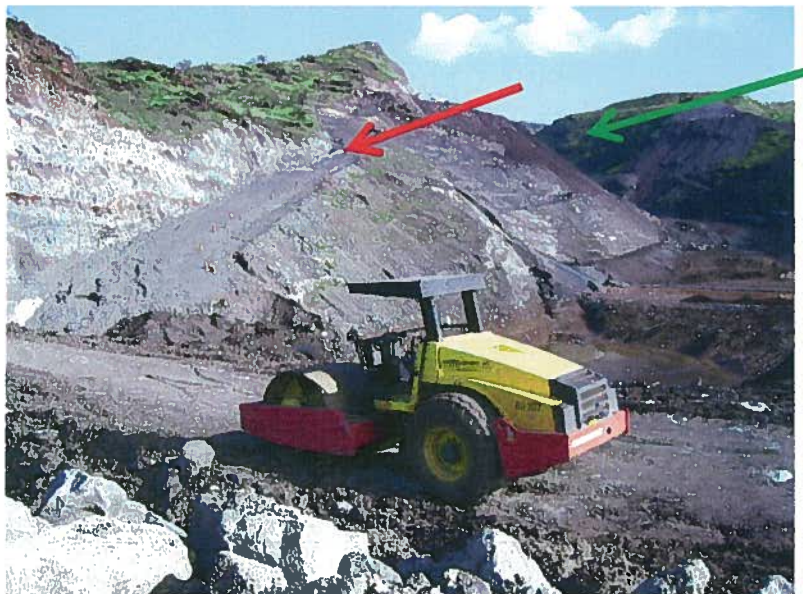
Photograph # 2

Description: With the construction of the headwall and storm water drainage system, storm water run-on would have diverted above and around the E6 cell (Red Arrow) and discharged through a large capacity "Hobas" pipe to the detention basin. The headwall (Green Arrow) is located upstream of the "Hobas" pipe.

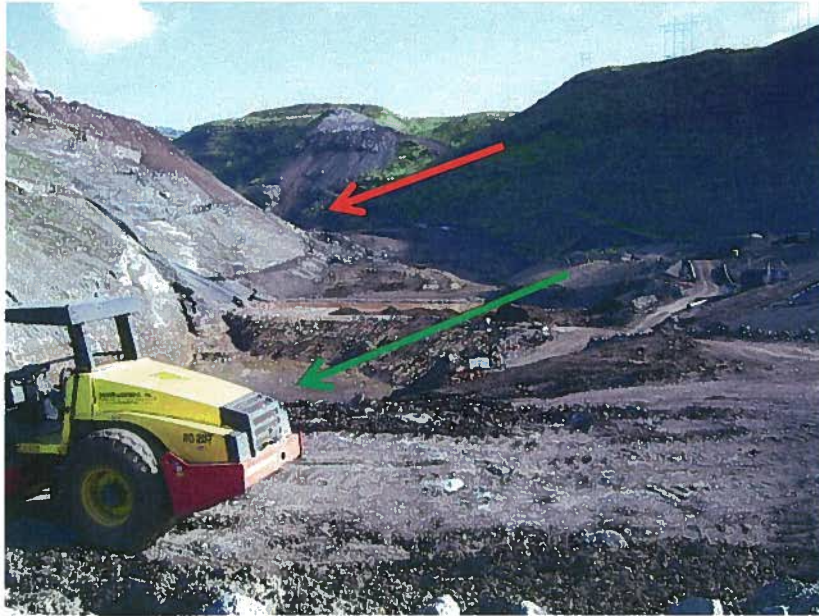
Photograph # 3

Description: View of the E6 cell facing north. J. Whelan indicated that the subsurface storm drain pipe inlet (Red Arrow) was not designed to address possible storm water run-on. J. Whelan stated that the area south of the main part of the E6 cell (Green Arrow) where storm water accumulated was not part of the E6 cell. It is unclear as to why J. Whelan indicated that the area immediately south of the E6 cell was not in fact part of the E6 cell when the same area had been identified as part of the E6 cell by J. Lottig during previous inspections.

2) During the inspection conducted on December 23, 2010 (Investigation Report ID#s PA0991 and 0991A), J. Lottig had indicated to CWB representatives that a 36 inch subsurface pipe located under the E6 cell was designed to divert storm water run-on to prevent the flooding of the E6 cell in the event of a storm. At the tour conducted on January 6, 2011, J. Whelan stated that in its current configuration, the Landfill was not able to divert storm water run-on around the E6 cell. J. Whelan stated that the 36 inch subsurface storm water pipe which has an inlet/manhole north of the E6 cell (Photograph 3) was not in fact designed to divert storm water run-on. J. Whelan explained that the 36 inch subsurface pipe was a drainage pipe for storm water which fell directly on the E6 cell. When asked to clarify, J. Whelan reiterated that the 36 inch subsurface pipe inlet located north of the E6 cell was not designed to handle storm water run-on. J. Whelan confirmed that the 36 inch subsurface storm water drainage pipe was designed only to manage storm water that fell on the E6 cell.
